## Building Abstract

### Headquarters

### Building 1

**Structure Number:** 1  
**Original Use:** Headquarters for N.W. Branch of the National Home  
**Present Use:** Veteran's Service Offices  
**Construction Date:** 1895  
**Architect:** Unknown  
**Number of Levels:** Three (including basement)  
**Total Area:** 17,600 square feet  
**Plan Shape:** Squared off "C"  
**Basic Construction:** Wood floor joists, masonry bearing walls  
**Uses per Floor:**  
Basement -  
9 Storage rooms, 2 Toilets, 1 Stairway  
First Floor -  
Lobby, 12 Offices, 2 Vaults, Janitors Closet and Toilet Room, 1 Stairway  
Second Floor -  
Bath, 5 Closets, Men's Toilet, 12 Offices, Conference Room, 1 Stairway

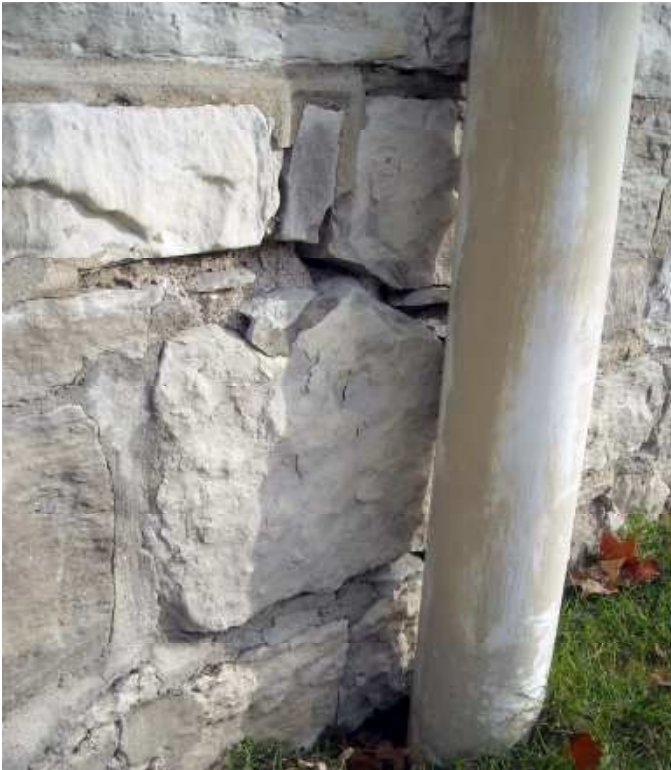
**1** Missing mortar at stone foundation wall.

Re-pointing of all existing masonry stone walls where cracking and deterioration has occurred should be addressed in the near future. Cleaning & removal of the surface deterioration that is currently present would also be recommended.

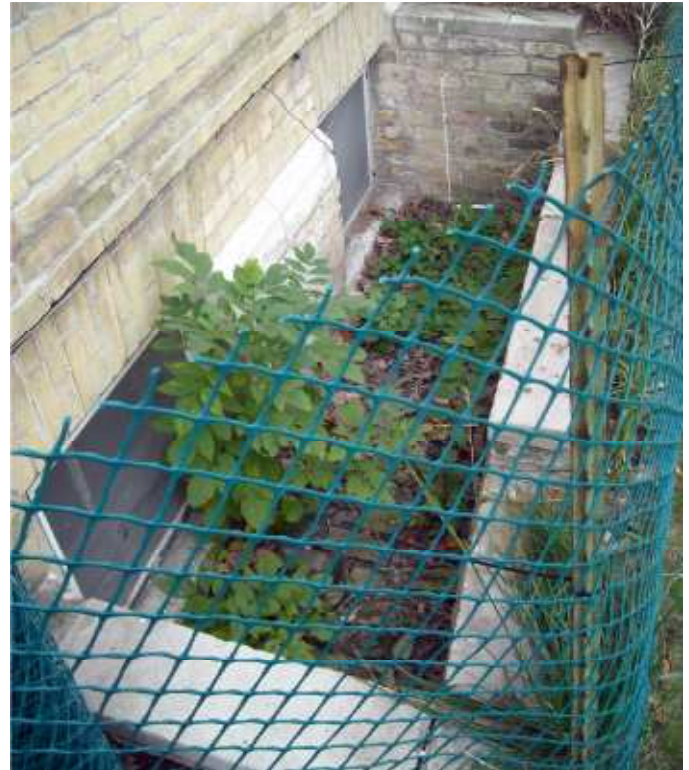
**2** Vegetation and debris in area well.

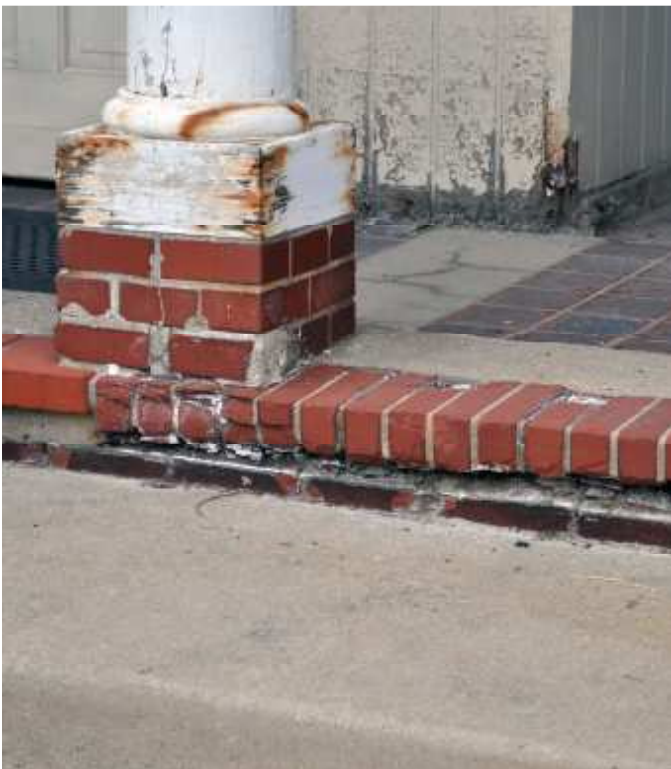
**3** Deteriorating brick pavers.

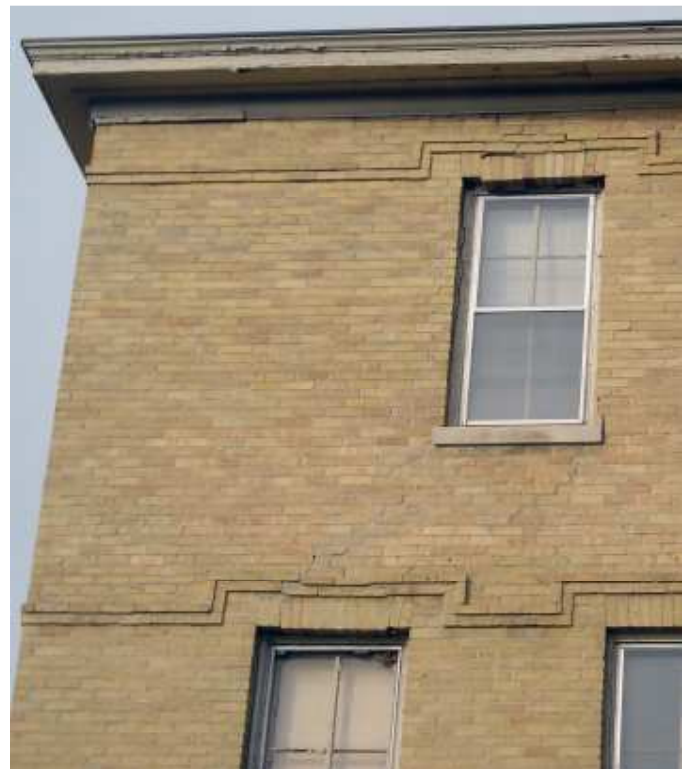
The building exterior shows general paint peeling from wood elements of the building skin. The brick is mostly in good condition except for the southeast corner of the building has cracking. This is possibly due to structural movement at the second floor level. A detailed structural analysis should be performed to determine the cause.

**4** Cracked and loose bricks.

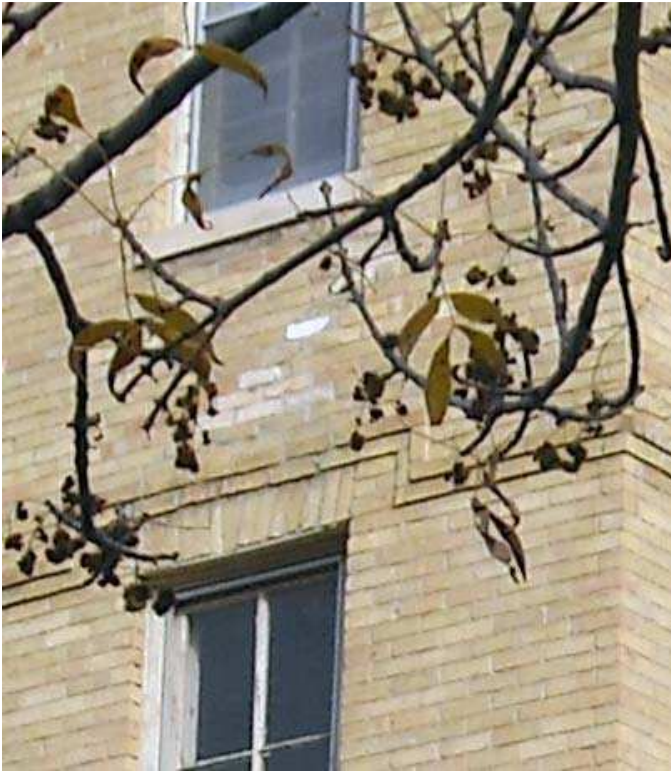
**5** Brick repair does not match existing adjacent brick.

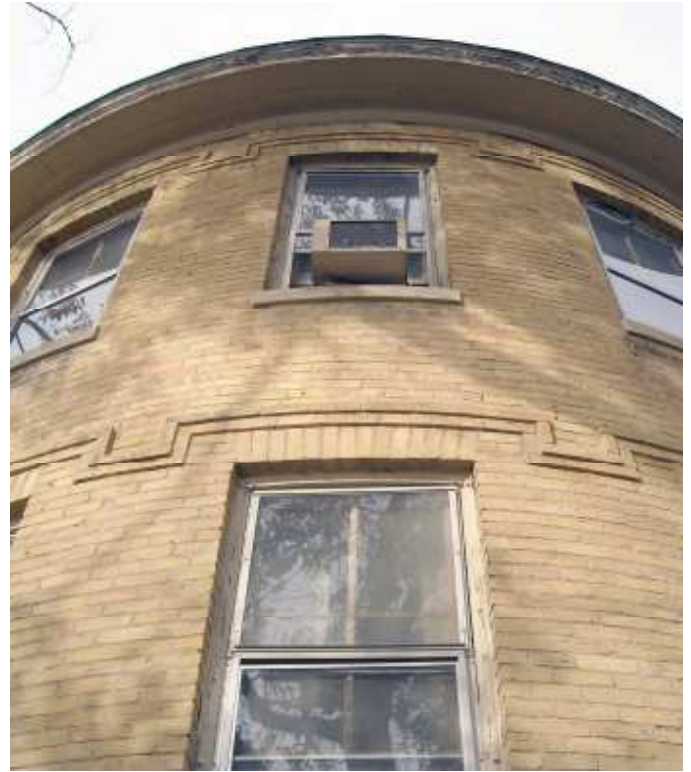
**6** Aluminum storm windows and AC unit not in character of building.

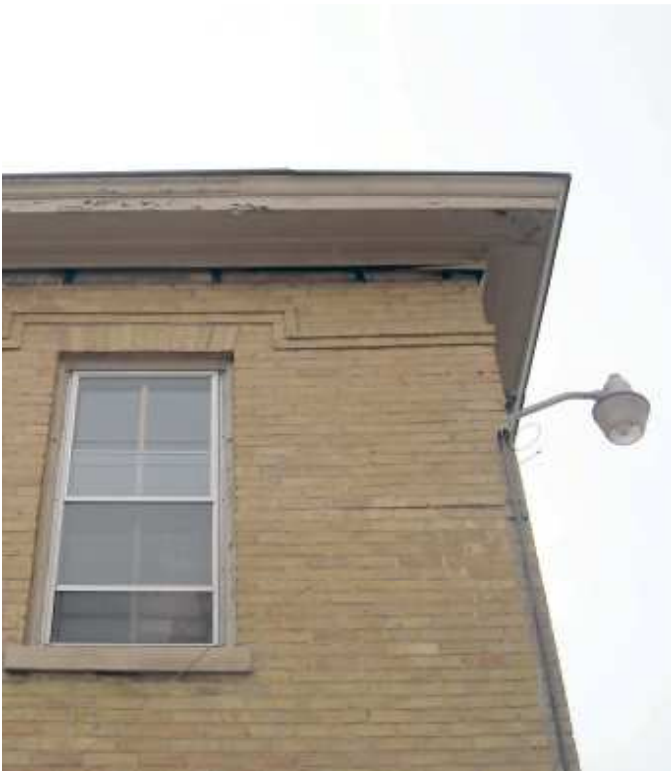
**7** Deteriorating wood soffit, trim & inappropriate light fixture.

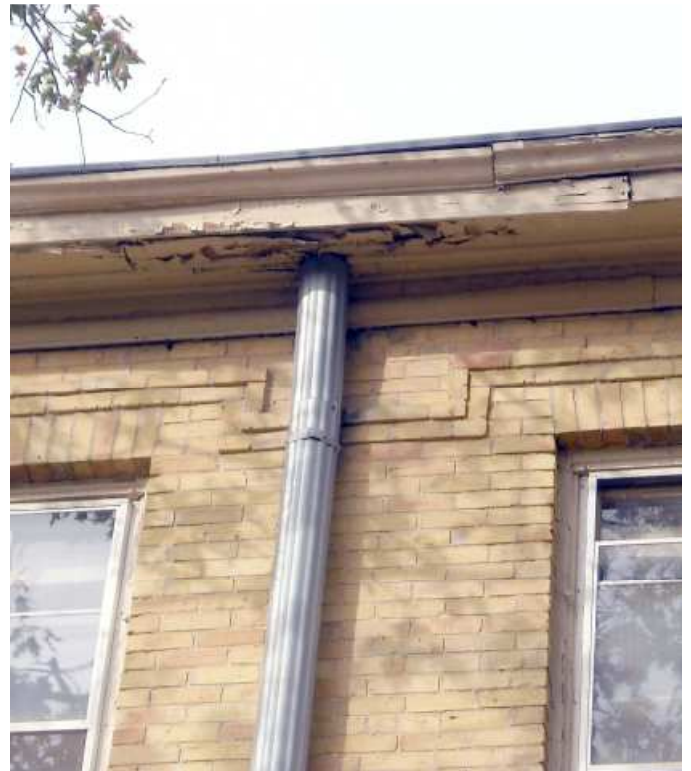
**8** Peeling paint at fascia and soffits.

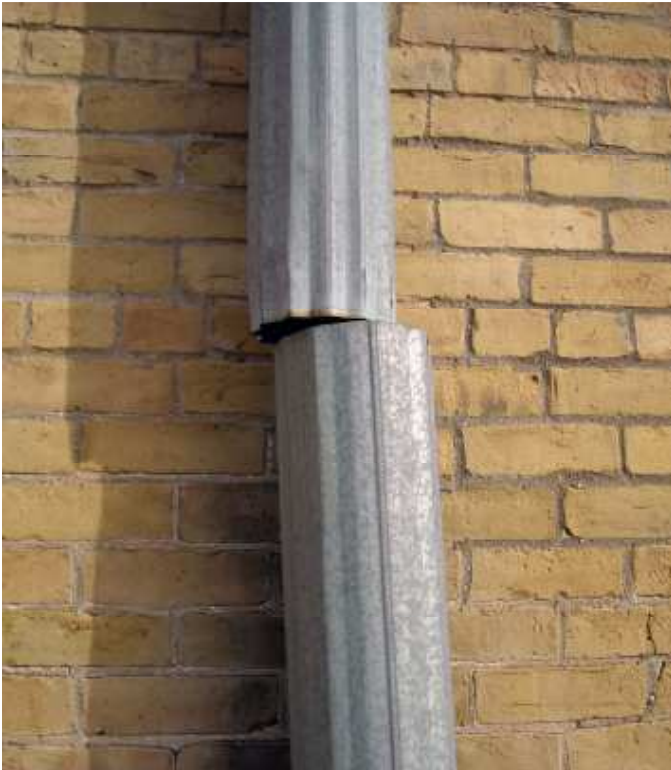
**9** Leak at downspout.

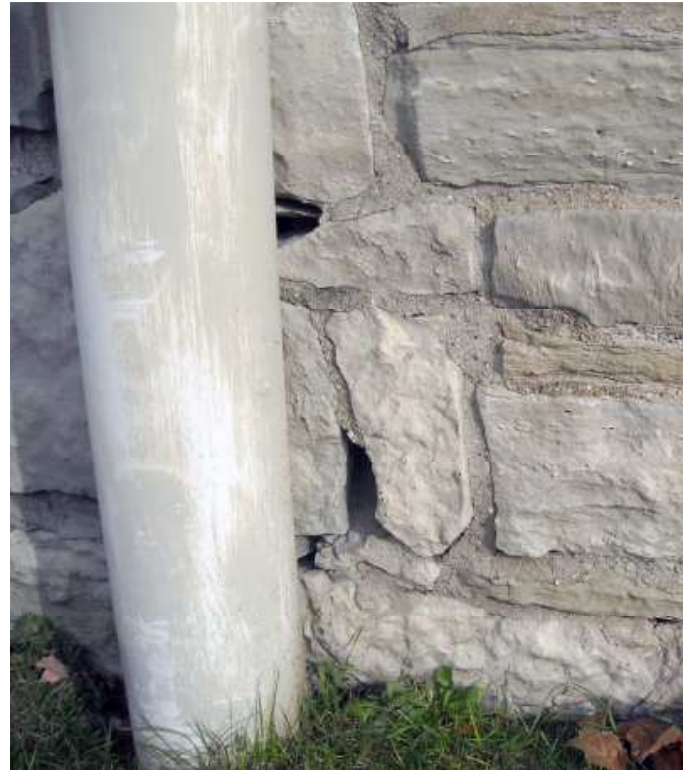
**10** Stone mortar washed away at downspout area.

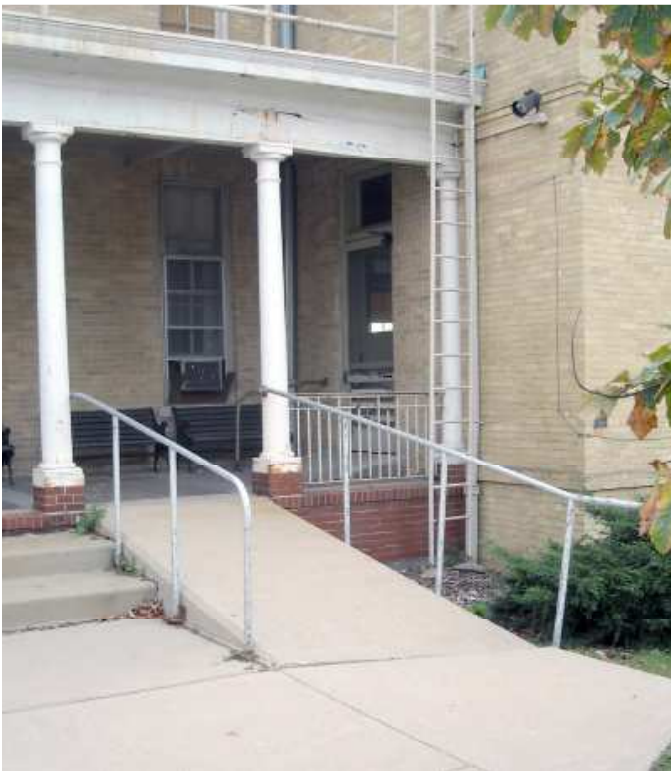
**11** Non-compliant handicap ramp and railing.

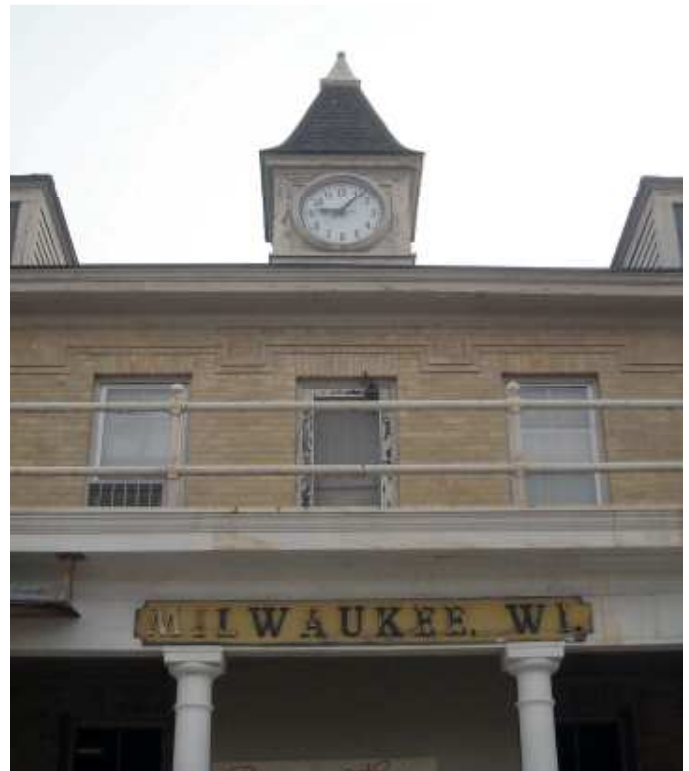
**12** Building signage paint peeling.

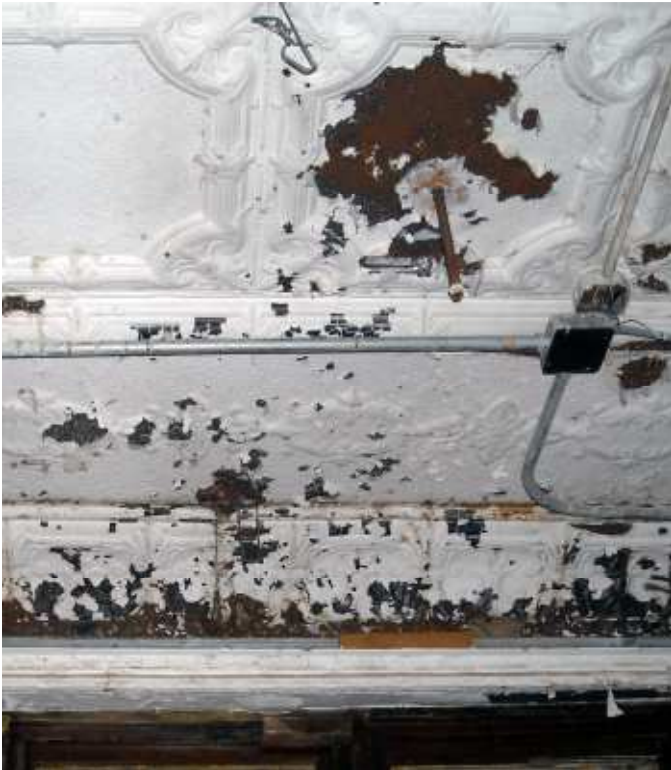
**13** *Paint peeling from tin ceiling.*

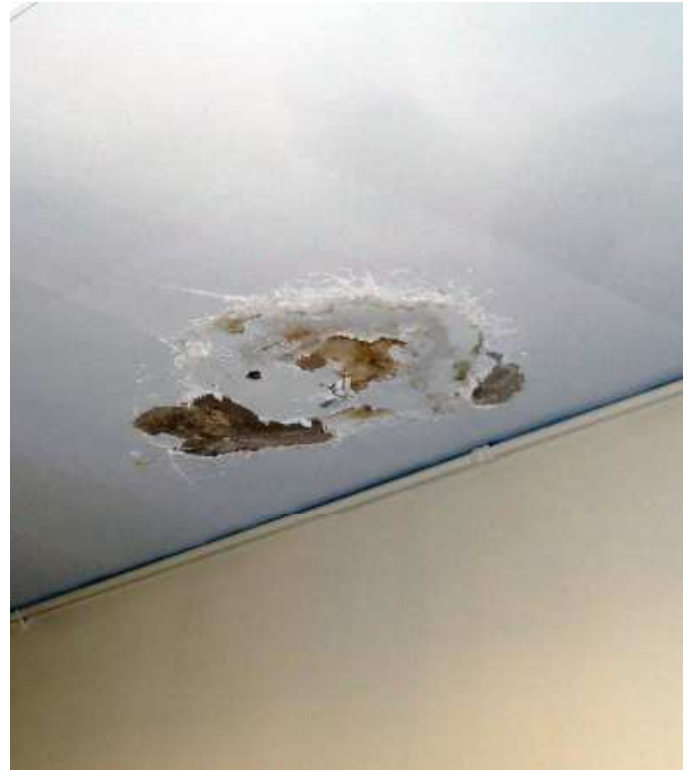
**14** *Water damage with paint peeling at plaster ceiling.*

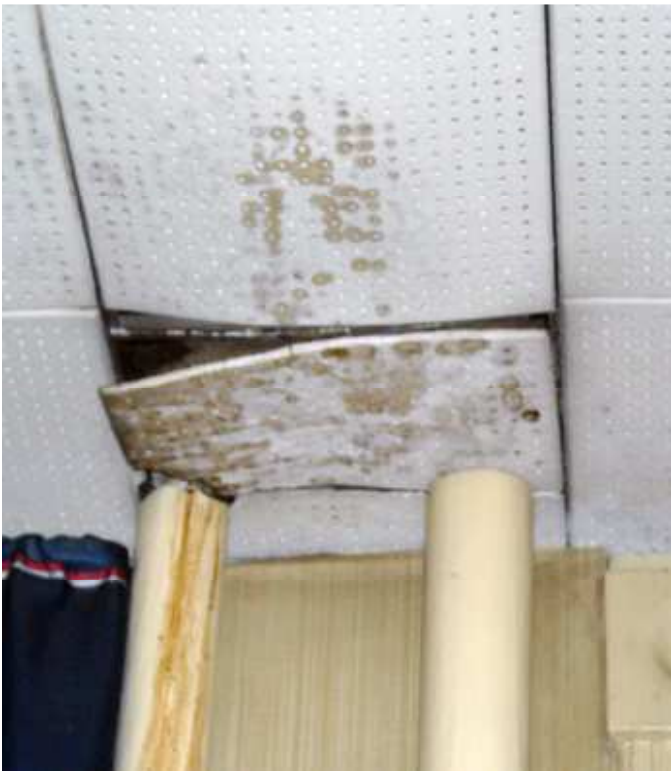
**15** *Water damaged acoustical ceiling tile.*

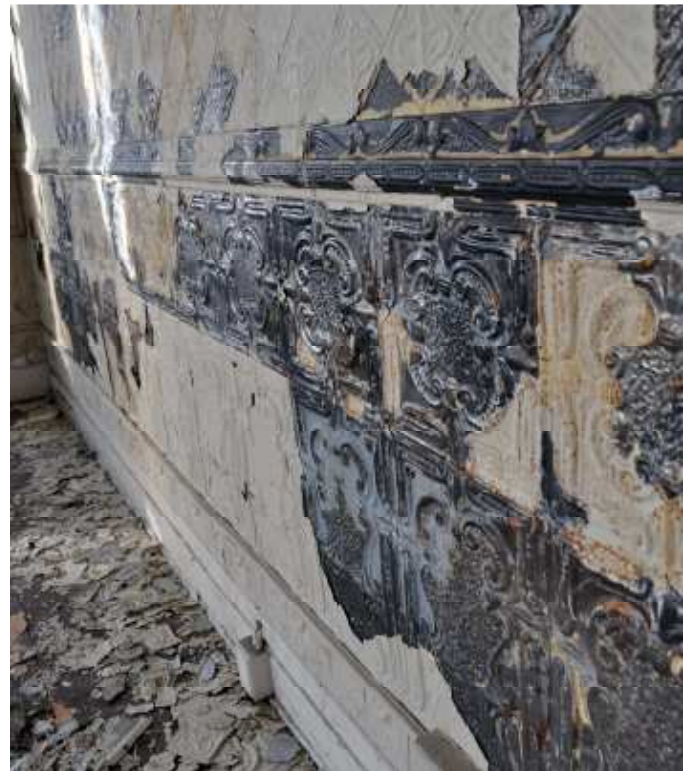
**16** *Paint peeling from tin wall covering.*

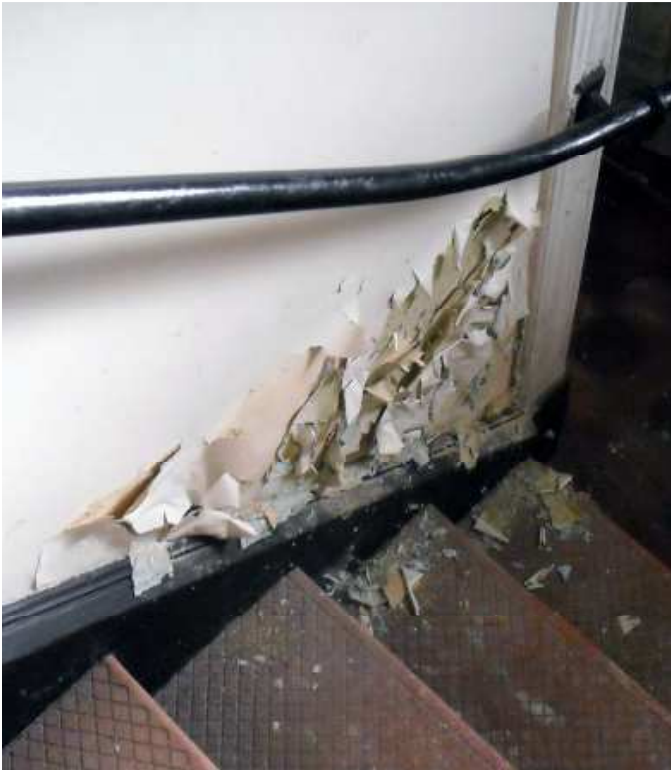
**17** Paint peeling plaster wall from moisture damage.

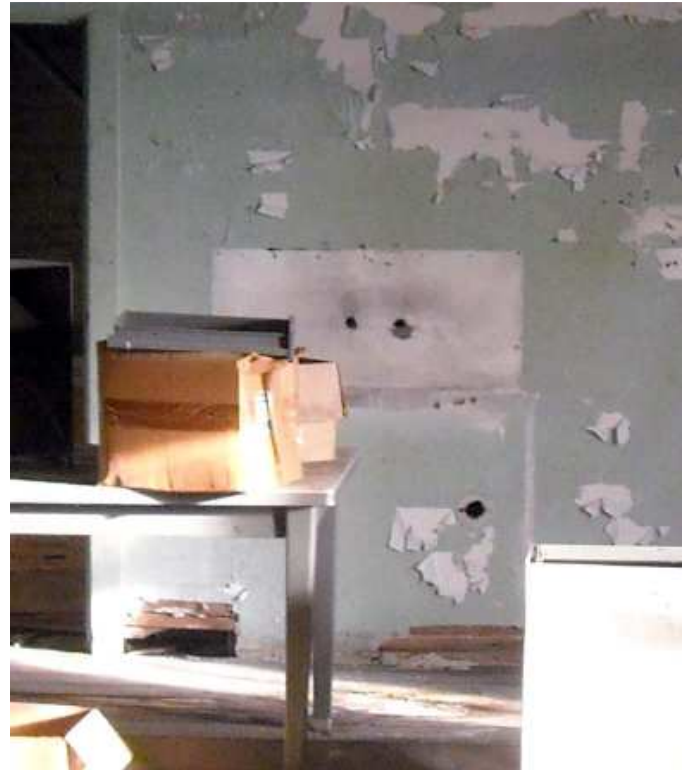
**18** Damaged wall from old plumbing fixtures.

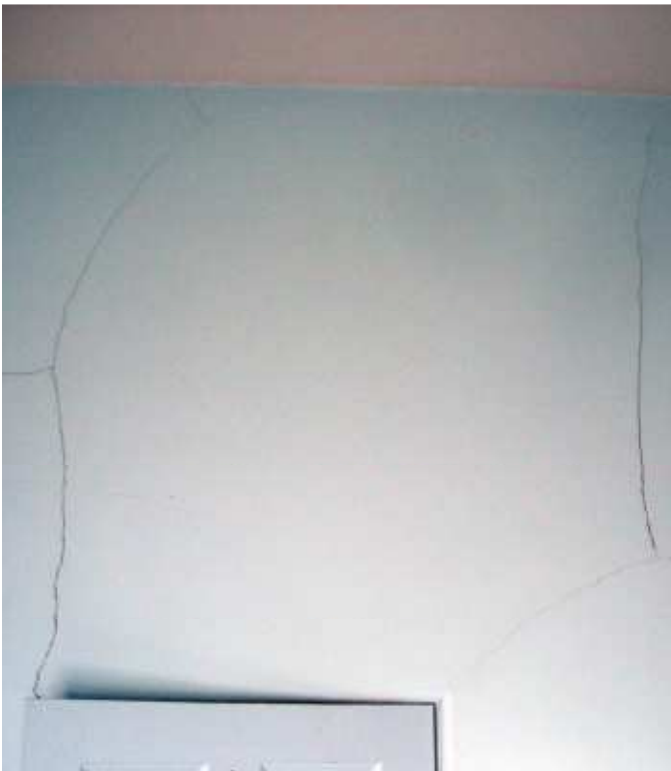
**19** Cracked and damaged plaster walls.

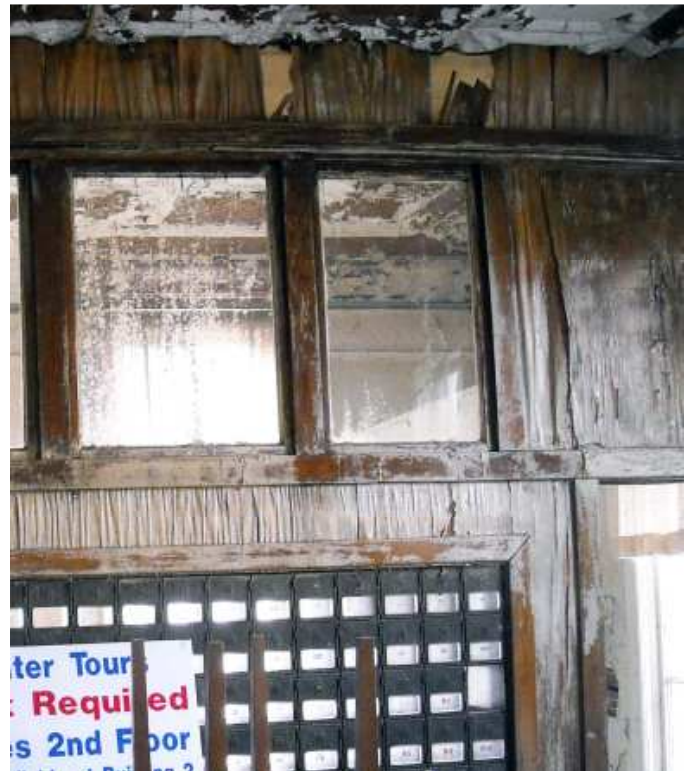
**20** Deteriorating wood partition wall with extensive water damage.

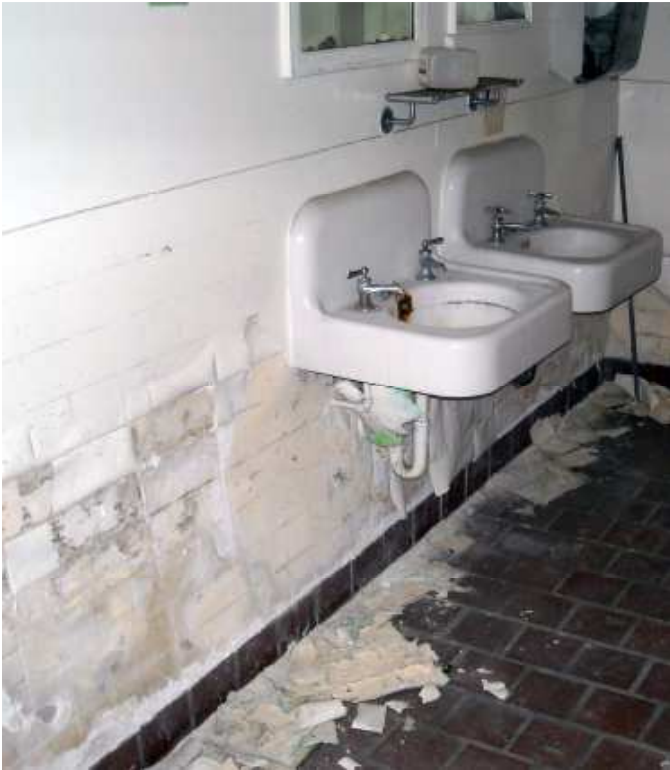
**21** Painted ceramic tiles in non-handicap accessible toilet room.

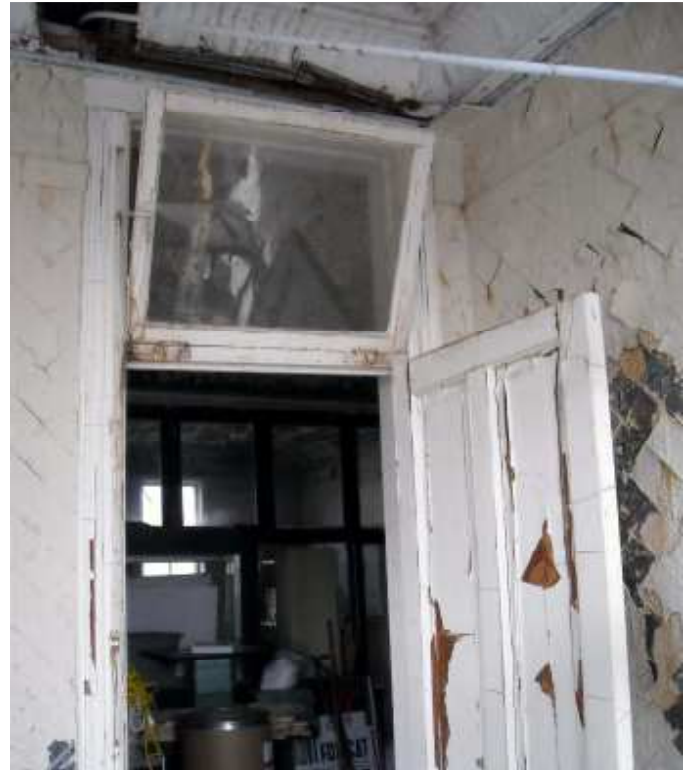
**22** Paint peeling from door assembly and tin wall covering.

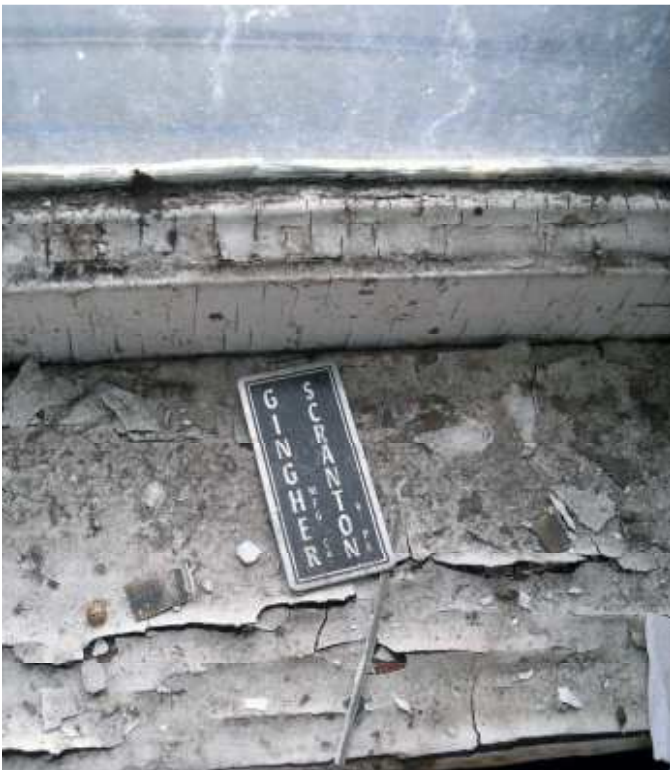
**23** Dirt, pollutants and paint peeling from window assembly.

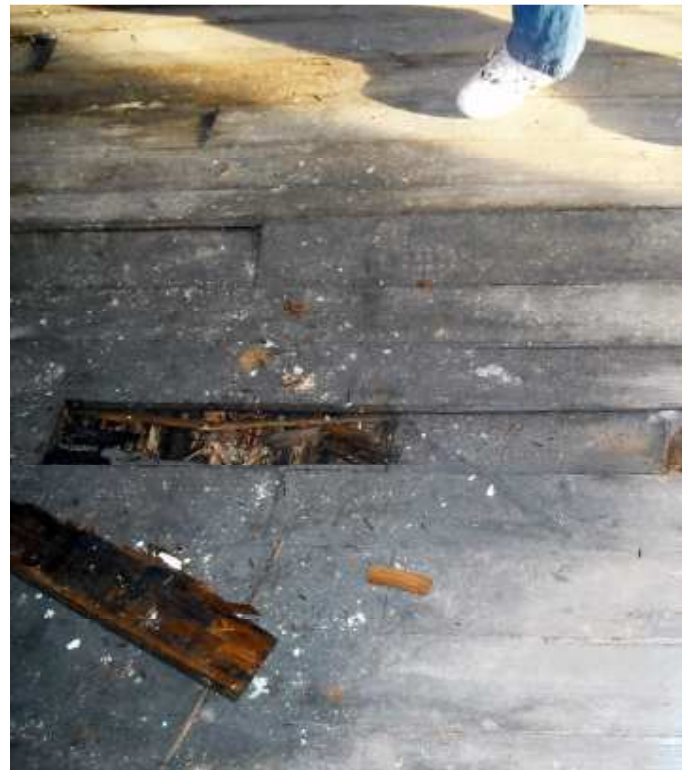
**24** Loose and missing floor boards.

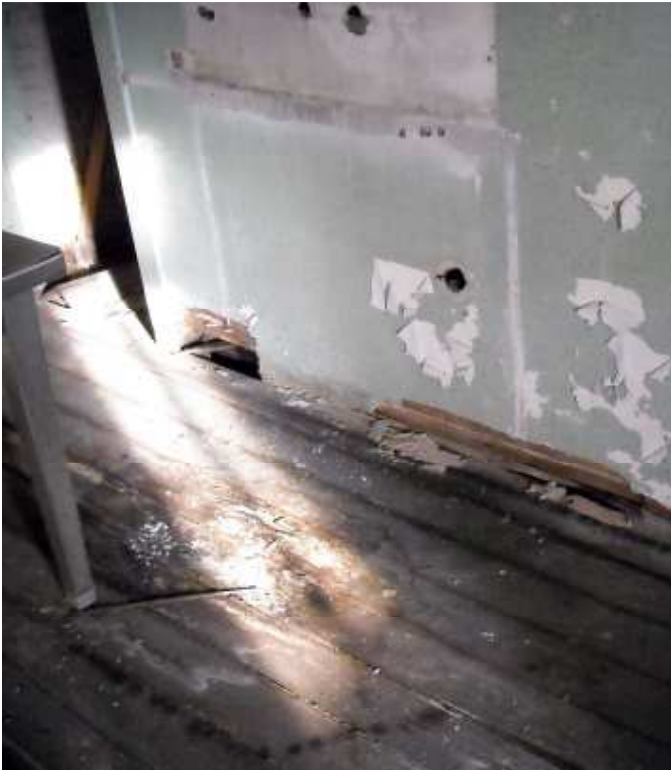
**25** *Dirt, pollutants and stained wood flooring.*

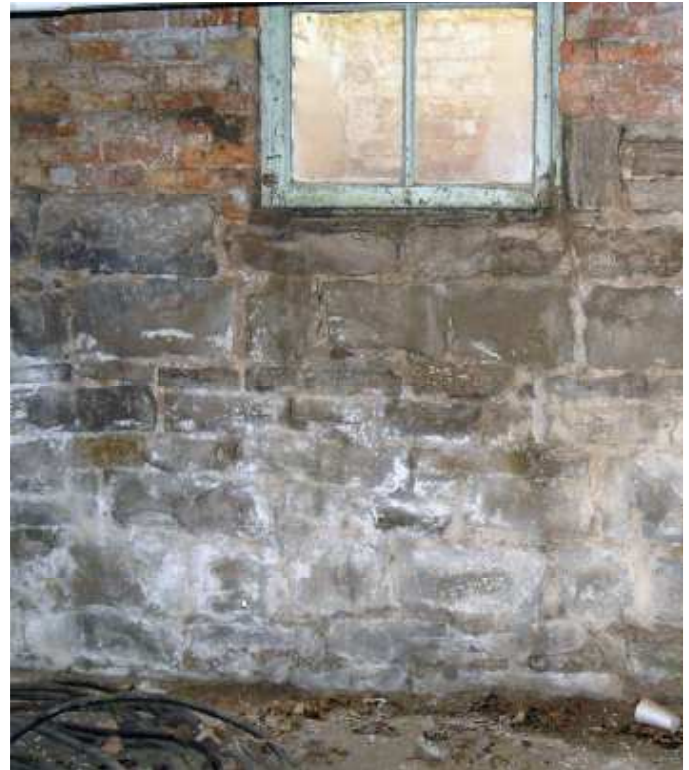
**26** *Dirt, pollutants and efflorescence on brick and stone wall.*

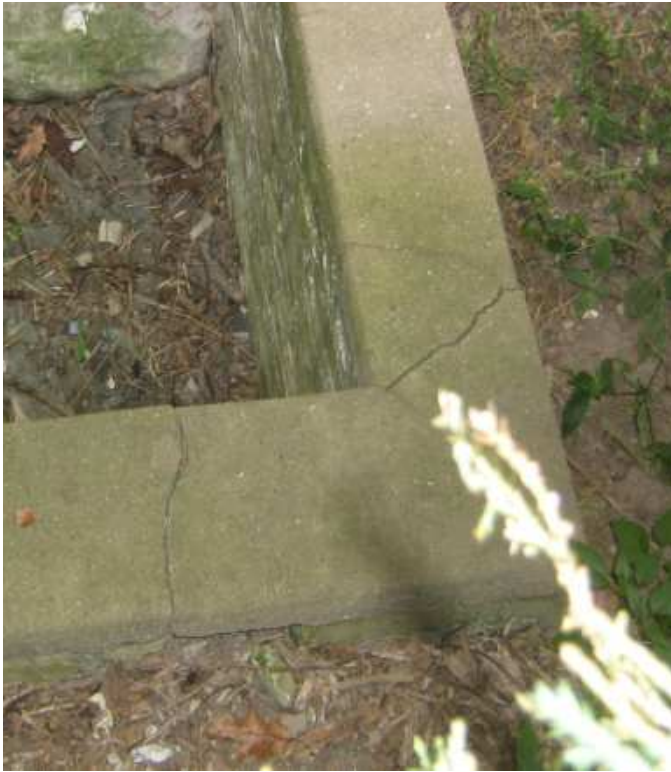
MINOR WALL REPAIRS ARE ALSO REQUIRED AT EXISTING AREA WELLS. MINOR CRACKING OF AREA WELL WALLS WERE NOTED & SHOULD BE ADDRESSED IN THE FUTURE.

**Photo 1:** Deterioration & Cracking at Existing Area Well Walls.

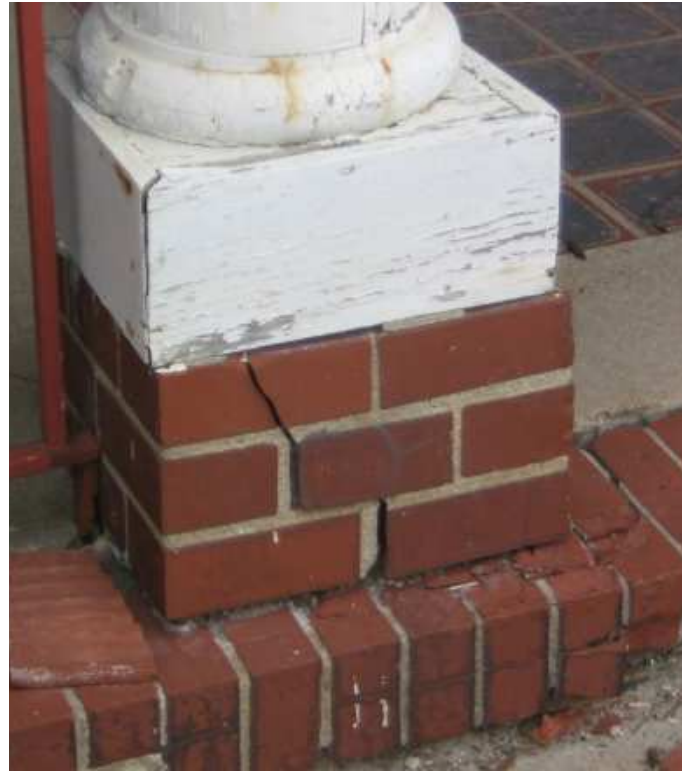
**Photo 2:** Deterioration & Cracking at Existing Column Base.

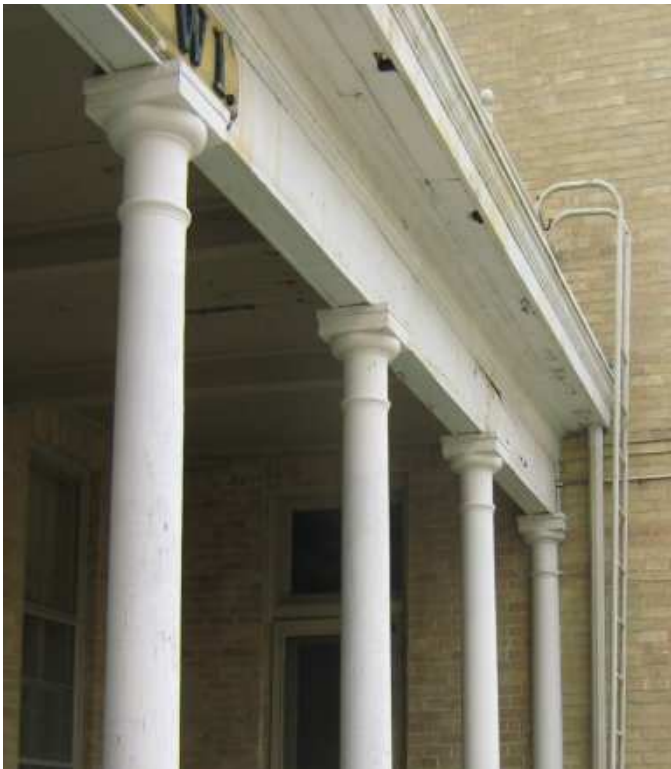
The majority of the existing wood roof framing was found to be in good condition, with exception to the roof framing associated with the flat-roof for the covered porch entry. In this instance, the exposed wood roof framing and associated wood columns have been left fully exposed to the weather. As a result, there is a presence of moisture damage & surface deterioration as evidence by the surface discoloration of the exposed wooden members. In some instances, many of the painted finishes are badly chipped and peeling.

**Photo 3:** Deterioration of Existing Wood Porch Framing.

In general it is recommended that all exposed exterior wood roof framing be cleaned and refinished to prevent further weathering and deterioration. Wood members that are structurally compromised should be replaced.

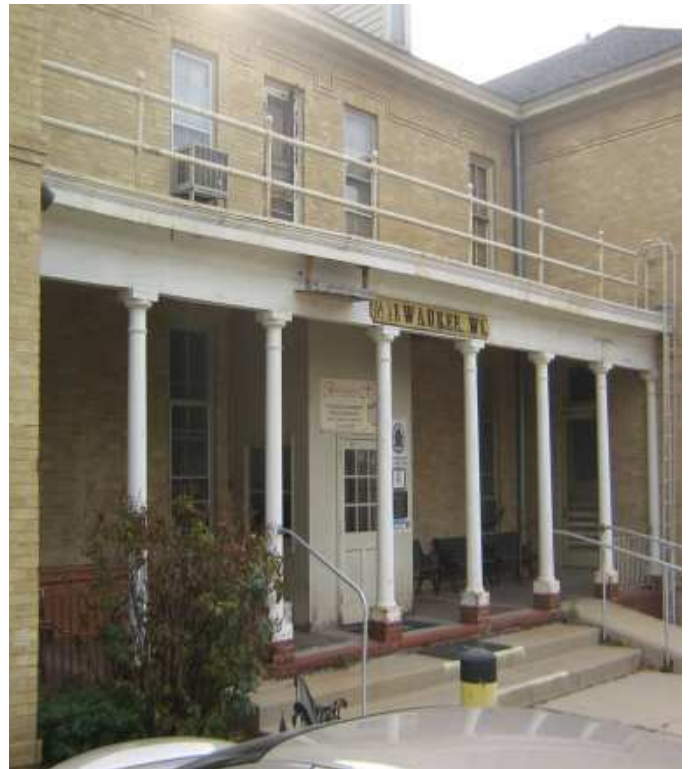
The flat roof & associated framing for the covered porch entry has experienced significant warping & structural deflection. This is more than likely the result of inadequate patio foundation construction and/or soil consolidation.

THE EXTERIOR ROOF FOR THE BUILDING WAS IN FAIR CONDITION, WITH EXCEPTION OF THE ROOF OVER THE PATIO WHERE STRUCTURAL DEFLECTION HAS CAUSED WARPAGE TO THE ROOF ITSELF. THE ROOFING SHOULD BE ADDRESSED IN THE NEAR FUTURE. IT IS RECOMMENDED THAT THE ROOF BE REMOVED & REBUILT IN ITS ENTIRETY TO PREVEN FURTHER DAMAGE.

**Photo 4:** Warping of Existing Patio Roof.

In regards to the roof construction associated with the flat roof for the covered porch entry, due to the severity of the structural damage that has already occurred, it is recommended that this portion of the roof, along with all associated roof support members be removed, with a new roof & structural support system be rebuilt in its place.

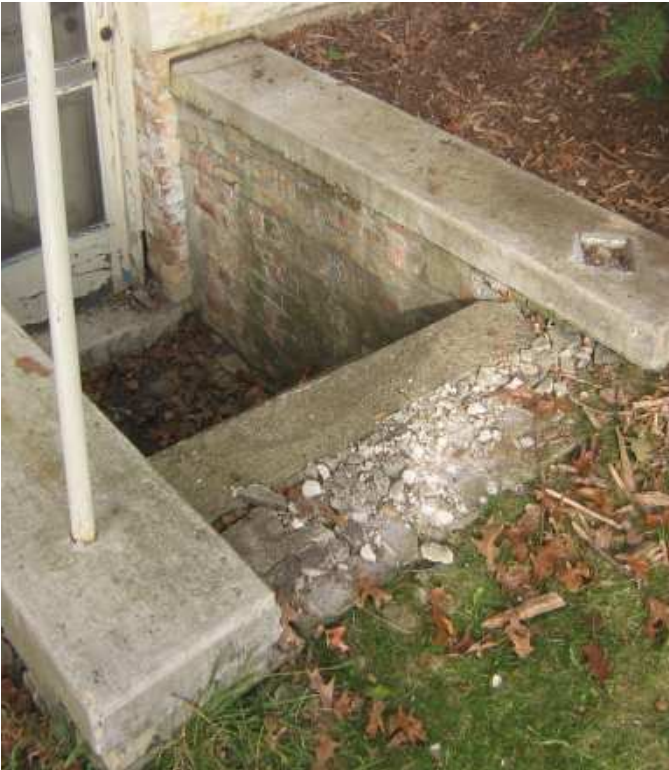
**Photo 5:** Cracking & Deterioration of Existing Concrete Stair.

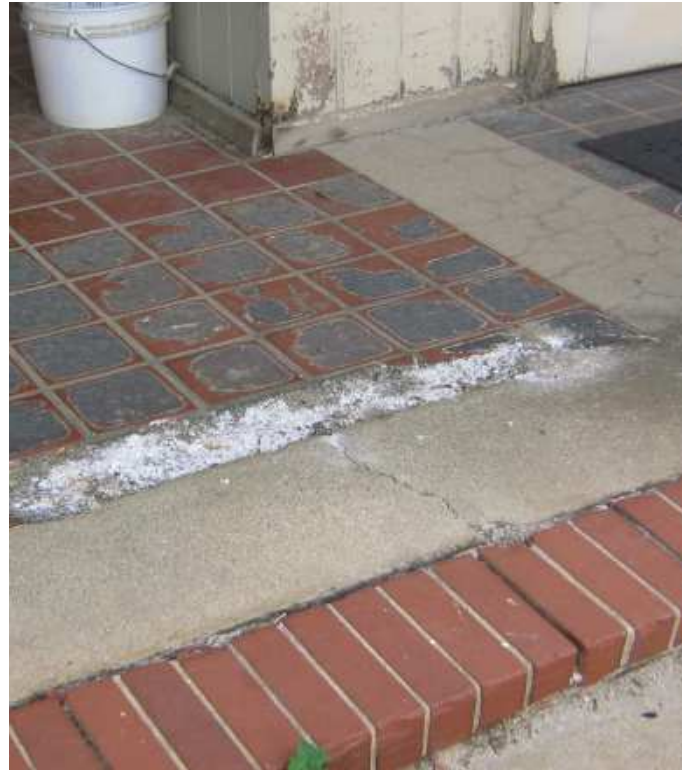
**Photo 6:** Cracking & Deterioration of Existing Concrete/Brick Patio Floor Slab.

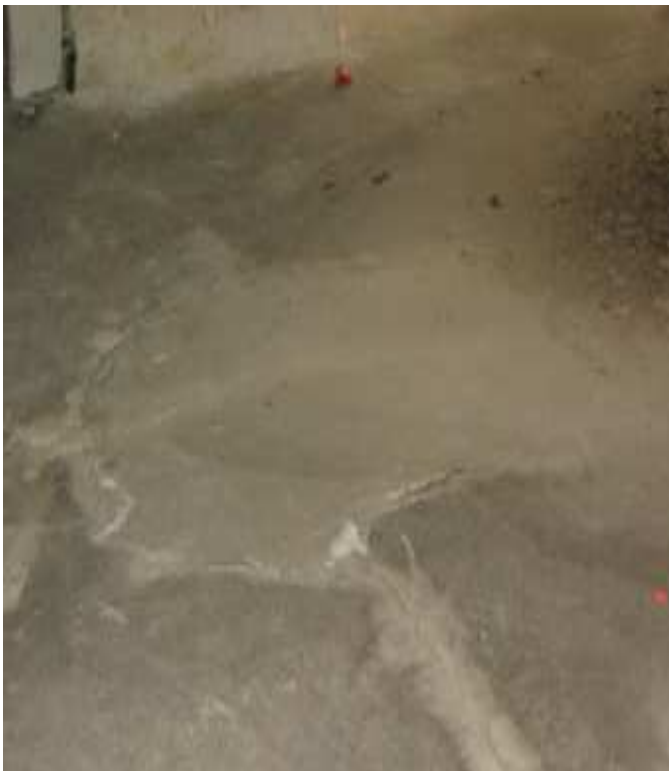
**Photo 7:** Cracking & Deterioration of Existing Concrete Floor Slab.

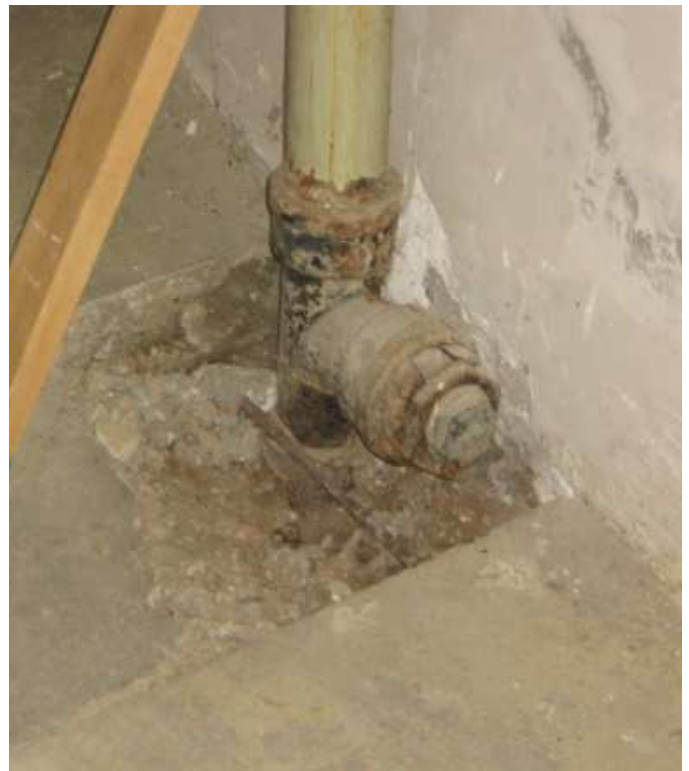
**Photo 8:** Missing Concrete Floor Slab.

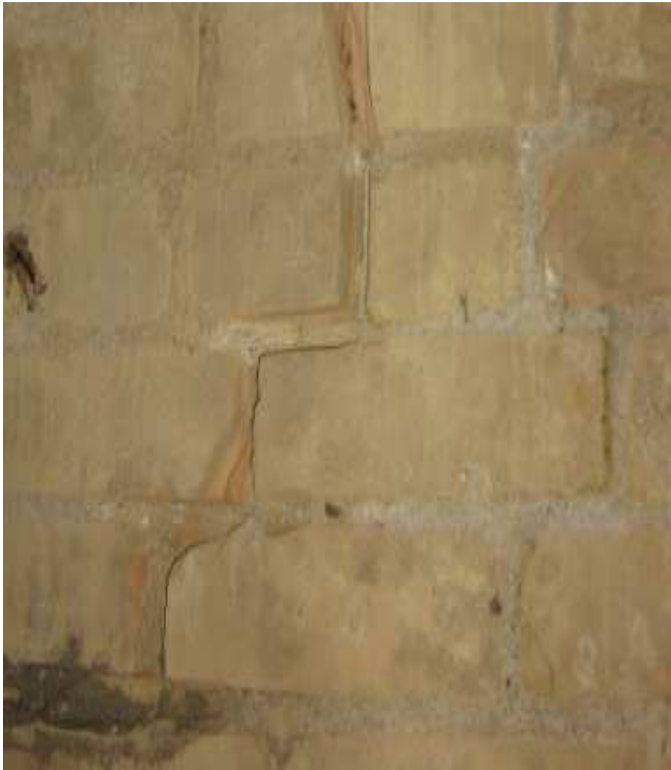
Some minor cracking is present on both the interior & exterior faces of the masonry foundation walls. Minor weathering and surface discoloration was also found.

**Photo 9:** Cracking & Deterioration of Existing Masonry Foundation Walls.

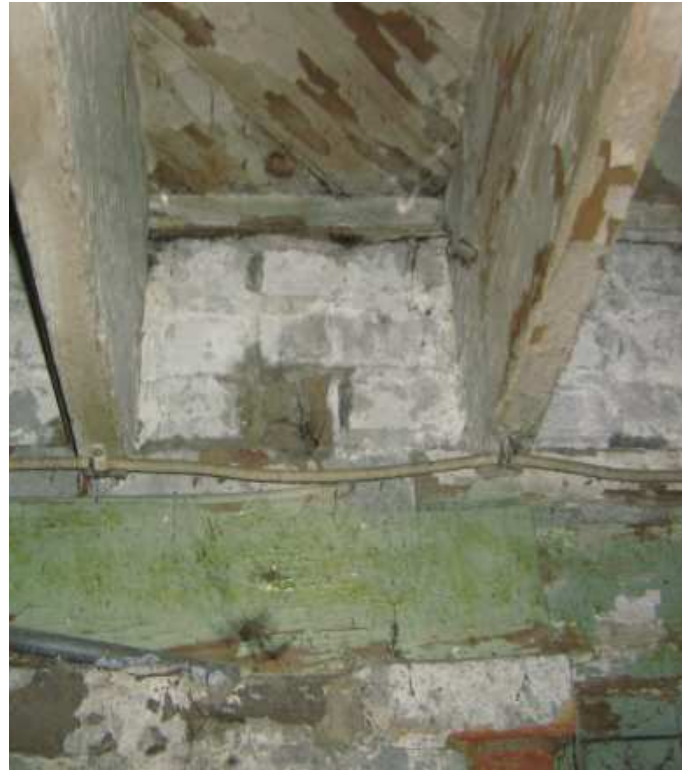
The majority of First & Second Floor framing are not readily visible due to the interior finishes present, with exception to the portions of the First Floor framing that have been left exposed from the basement. In this instance, the presence of moisture damage & surface deterioration were found as evidence by the surface discoloration of the exposed wood floor joists.

EXISTING WOOD FLOOR FRAMING HAS UNDERGONE MINOR DETERIORATION DUE TO MOISTURE PROBLEMS. IT IS RECOMMENDED THAT THE DAMAGED WOOD FLOOR FRAMING BE REFRESHED IN THE NEAR FUTURE TO PREVENT FURTHER DETERIORATION & DAMAGE.

**Photo 10:** Deterioration of Existing Wood Floor Framing.

In general it is recommended that all the exposed interior wood floor framing be cleaned and refinished to prevent further surface deterioration and damage.

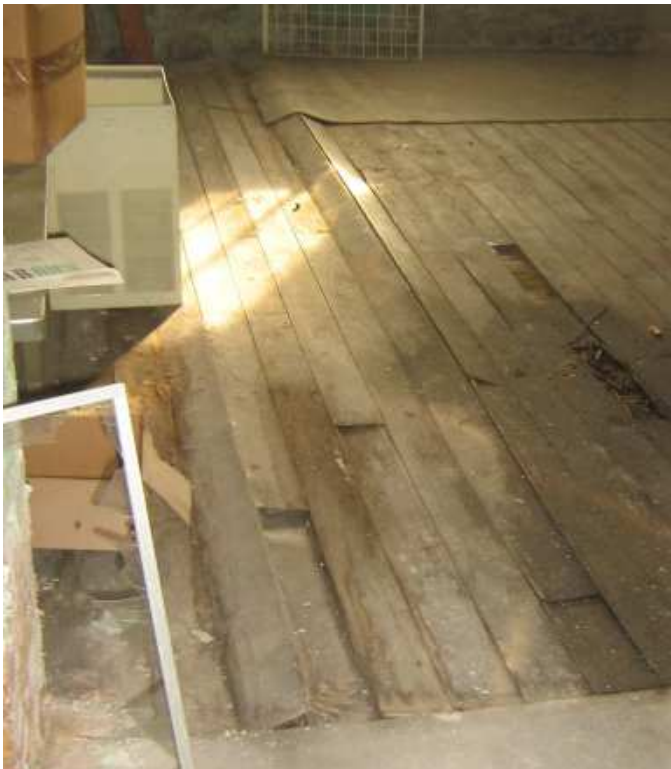
**Photo 11:** Heaving of Existing Basement Floor Boards.

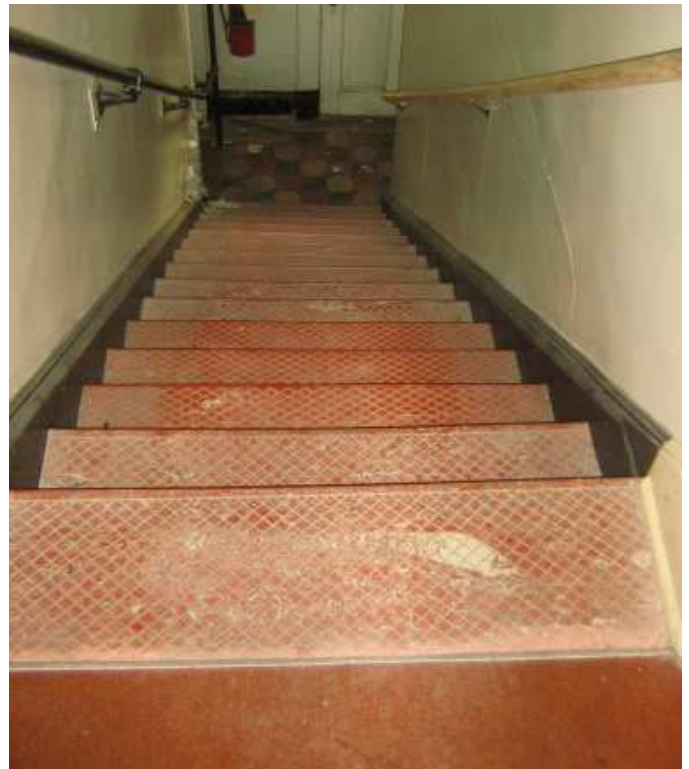
**Photo 12:** Warping of Existing Wood Stair.

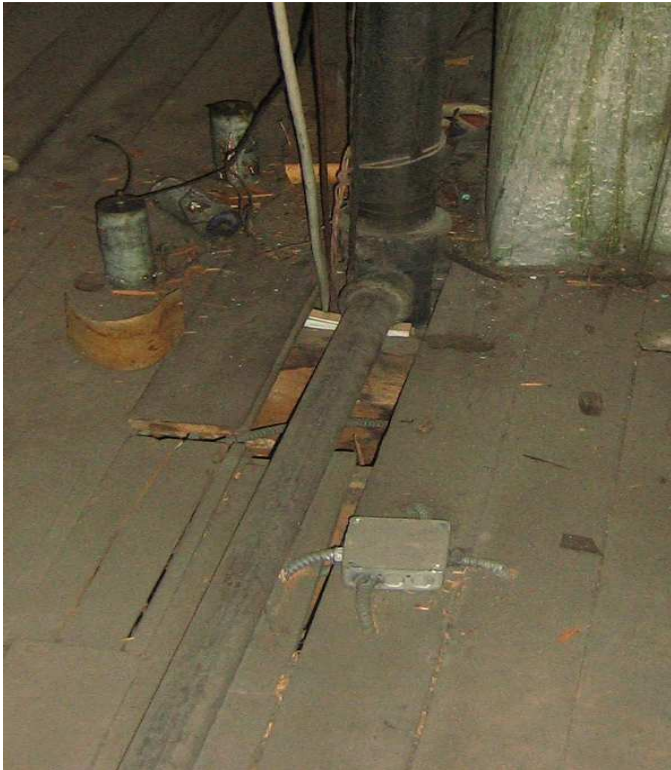
**Photo 13:** Damaged & Missing Roof Floor boards.

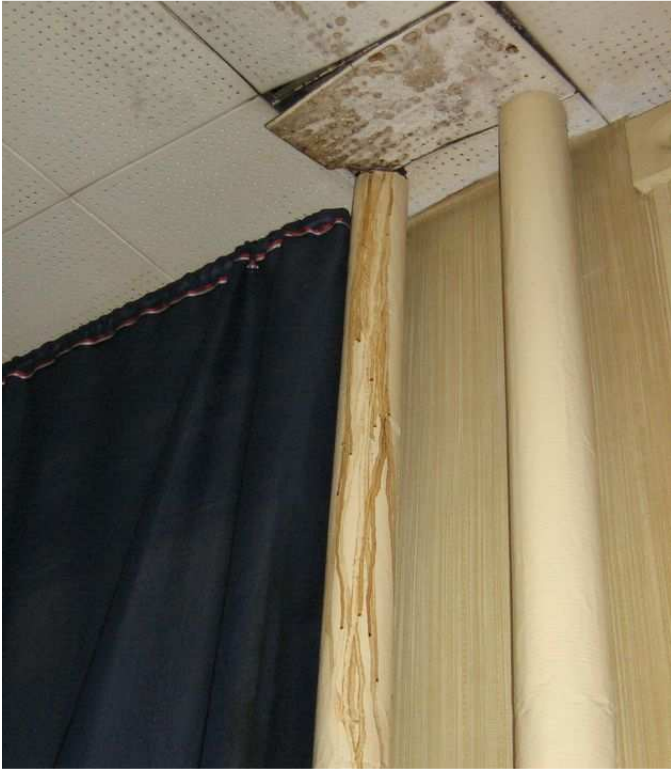
**1** *Water damaged ceiling tile.*

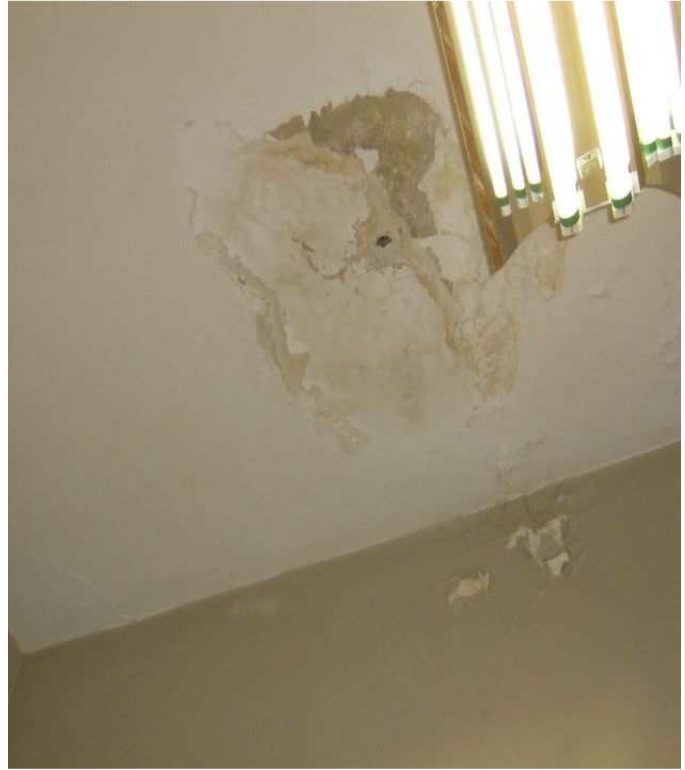
**2** *Damaged plaster ceiling and wall.*
